Test Report

n° RP 050717-01.1

| Sample identification | | Sedia Outline identified with code 050717-01-01 | |
| Standard | UNI EN 16139:2013 | Title | Furniture. Strength, durability and safety. Requirements for non-domestic seating. Par. 6 Test methods. Test 1 Seat and back static load test. |

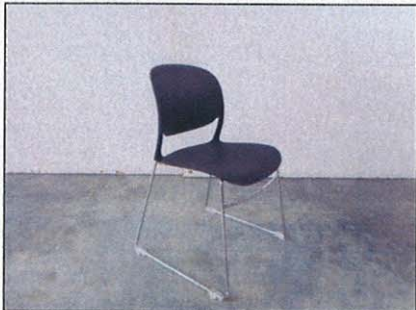
| Test level | Typology of use | Force applied on seat | Force applied on back | Number of cycles | Results |
|---|---|---|---|---|---|
| 2 | Extreme use | 2000 N | 700 N | 10 | Successful |

At the end of the test there are no fractures of any member, joint or component. There is no loosening of joints intended to be rigid. No major structural element is significantly deformed. The seating fulfils its functions after removal of the test loads and the stability requirements.

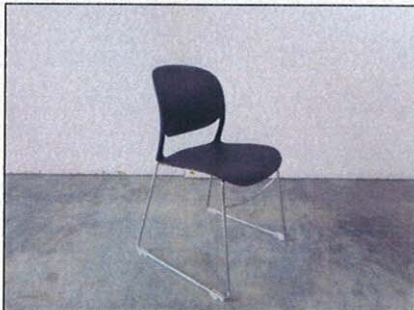
| Standard | UNI EN 16139:2013 | Title | Furniture. Strength, durability and safety. Requirements for non-domestic seating. Par. 6 Test methods. Test 8 Seat and back durability test. |

| Test level | Typology of use | Force on seat | Force on back | Number of cycles | Results |
|---|---|---|---|---|---|
| 2 | Extreme use | 1000 N | 300 N | 200.000 | Successful |

At the end of the test there are no fractures of any member, joint or component. There is no loosening of joints intended to be rigid. No major structural element is significantly deformed. The seating fulfils its functions after removal of the test loads and the stability requirements.

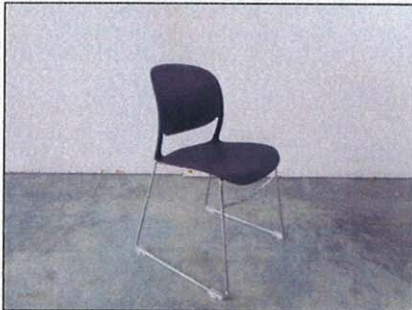
| Standard | UNI EN 16139:2013 | Title | Furniture. Strength, durability and safety. Requirements for non-domestic seating. Par. 6 Test methods. Test 3 Vertical static load on back. |

| Test level | Typology of use | Force applied | Number of cycles | Results |
|---|---|---|---|---|
| 2 | Extreme use | 900 N | 10 | Successful |

At the end of the test there are no fractures of any member, joint or component. There is no loosening of joints intended to be rigid. No major structural element is significantly deformed. The seating fulfils its functions after removal of the test loads and the stability requirements.

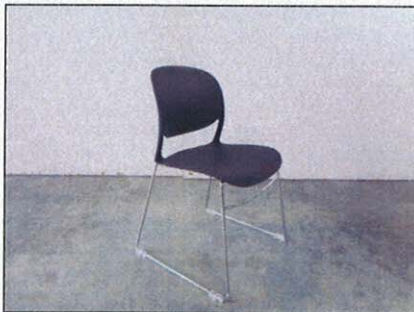
| Standard | UNI EN 16139:2013 | Title | Furniture. Strength, durability and safety. Requirements for non-domestic seating. Par. 6 Test methods. Test 9 Seat front edge durability test. |

| Test level | Typology of use | Force on seat | Number of cycles | Results |
|---|---|---|---|---|
| 2 | Extreme use | 800 N | 100.000 | Successful |

At the end of the test there are no fractures of any member, joint or component. There is no loosening of joints intended to be rigid. No major structural element is significantly deformed. The seating fulfils its functions after removal of the test loads and the stability requirements.

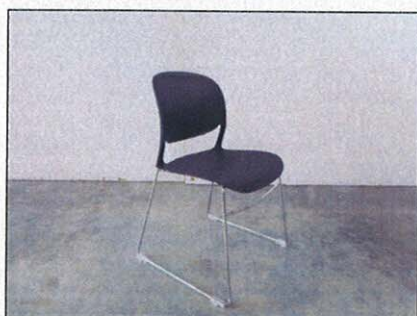
| Standard | UNI EN 16139:2013 | Title | Furniture. Strength, durability and safety. Requirements for non-domestic seating. Par. 6 Test methods. Test 14 Seat impact test. |

| Test level | Typology of use | Drop height | Number of cycles | Results |
|---|---|---|---|---|
| 2 | Extreme use | 300 mm | 10 | Successful |

At the end of the test there are no fractures of any member, joint or component. There is no loosening of joints intended to be rigid. No major structural element is significantly deformed. The seating fulfils its functions after removal of the test loads and the stability requirements.

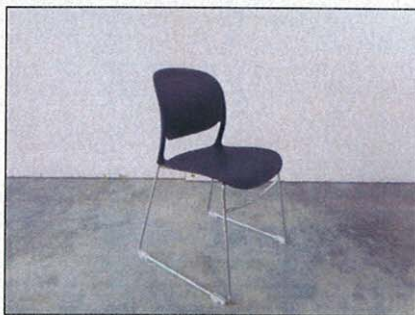
| Standard | UNI EN 16139:2013 | Title | Furniture. Strength, durability and safety. Requirements for non-domestic seating. Par. 6 Test methods. Test 15 Back impact test. |

| Test level | Typology of use | Drop height | Drop angle | Number of cycles | Results |
|---|---|---|---|---|---|
| 2 | Extreme use | 330 mm | 48 ° | 10 | Successful |

At the end of the test there are no fractures of any member, joint or component. There is no loosening of joints intended to be rigid. No major structural element is significantly deformed. The seating fulfils its functions after removal of the test loads and the stability requirements.
